PCBs IN TORCH LAKE: WHAT'S THE STORY?

PCBs AND TORCH LAKE – ARE THEY A CONCERN?

Torch Lake, one hub of mining-related activities, has become the center of efforts by regulatory agencies to mitigate harmful impacts from these activities. This project by researchers at Michigan Technological University, funded by Michigan Sea Grant, seeks to assemble and to evaluate available information, to identify critical information gaps, and, through working with local stakeholders and government agencies, to identify possible pathways towards improved conditions in and around Torch Lake.

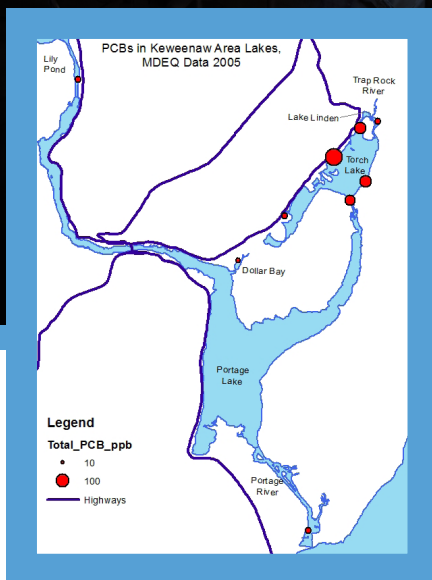
This map shows that concentrations of PCBs in Torch Lake water were much higher than in water from the Keweenaw Waterway, Dollar Bay and Huron Bay.

The figure above shows that concentrations of PCBs in Torch Lake water were much higher than in nearby waterways.
